A Pesky Pigeon Poop Problem

Chicago, Illinois

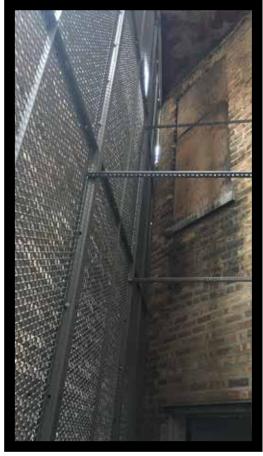
As for the pigeons, the final solution was to erect an odd-shaped single-wall partition that was 16' wide x 20' tall. The posts anchored to the porch floor and extended up to the underside of the third-floor ceiling. The partition panels were made of expanded metal and went from floor to ceiling. The wall was laterally braced every 10 to 17 feet.

The small diamond mesh expanded metal panels along with trimming the top, bottom, and side gaps provided the necessary guarding to keep any size bird out of this area. It offered a clean space while still allowing light and airflow to keep the area cool and dry.
